**BUILDING SURVEY**

INSTITUTION LAURELTON CENTER DATE OF SURVEY May 15, 1995

BUILDING: No. 17 NAME Glover Hall DATE BUILT 1949

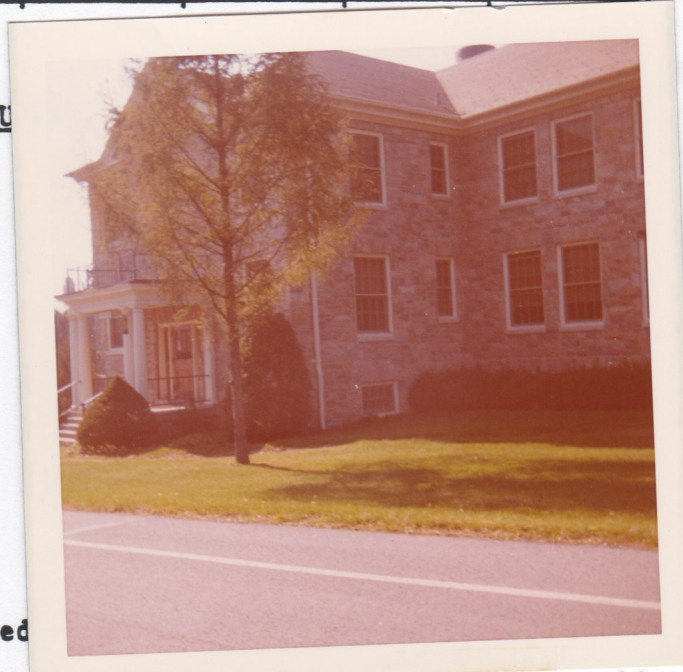
DESCRIPTION OF CONSTRUCTION Roof-asbestos shingles over wood frame;  
Exterior walls-stone; Interior Walls-tile and plaster; Foundation and  
Floors-concrete; Window air conditioning

GENERAL CONDITION OF BUILDING EXCELLENT V. GOOD GOOD FAIR POOR V. POOR  
 X

1. Replace existing windows with insulated
2. Central Air Conditioning.
3. Renovate Bathrooms (Modernize).
4. Replace rear porch roof.
5. Replace asbestos shingle roof.
6. Replace downspout and airway drains around building.
