BUILDING SURVEY

INSTITUTION LAURELTON CENTER DATE OF SURVEY May 15, 1995

BUILDING: No. 09 NAME Jolly Hall DATE BUILT 1938

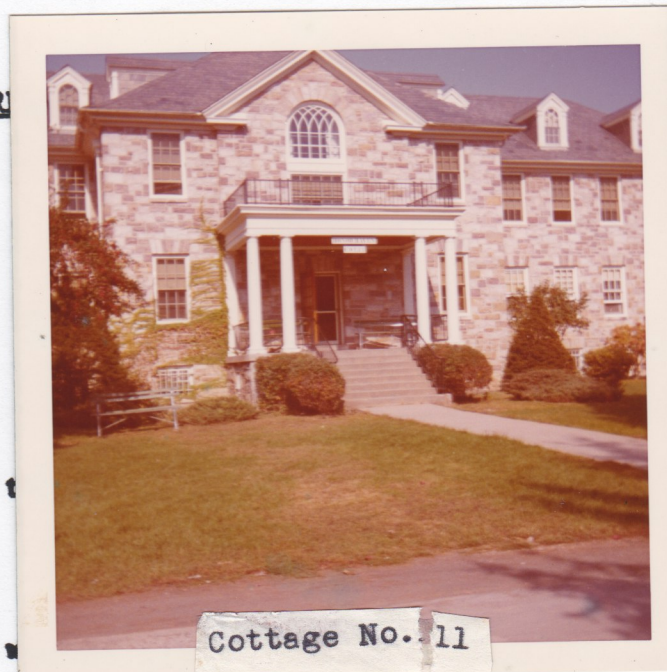
1. Replace galvanized water piping.
2. Replace front porch roof (flat built-up) many times still leaks.

1. Replace existing windows with insulated
2. Central Air Conditioning
