BUILDING SURVEY

INSTITUTION LAURELTON CENTER DATE OF SURVEY May 15, 1995

BUILDING: No. 01 NAME Karstetter Hall DATE BUILT 1913

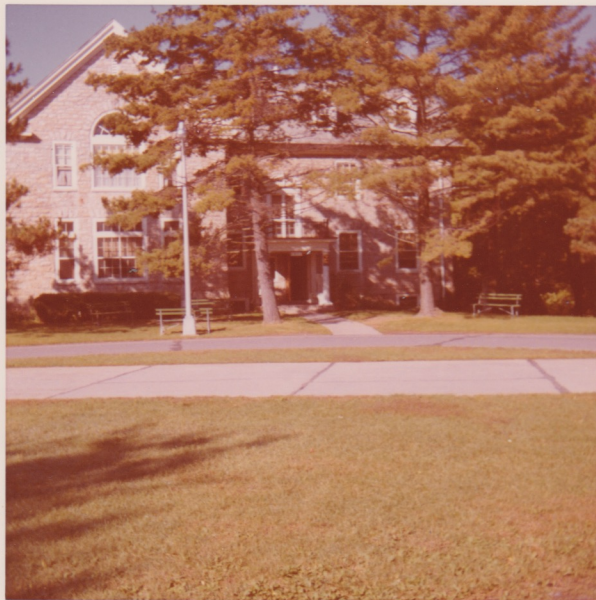
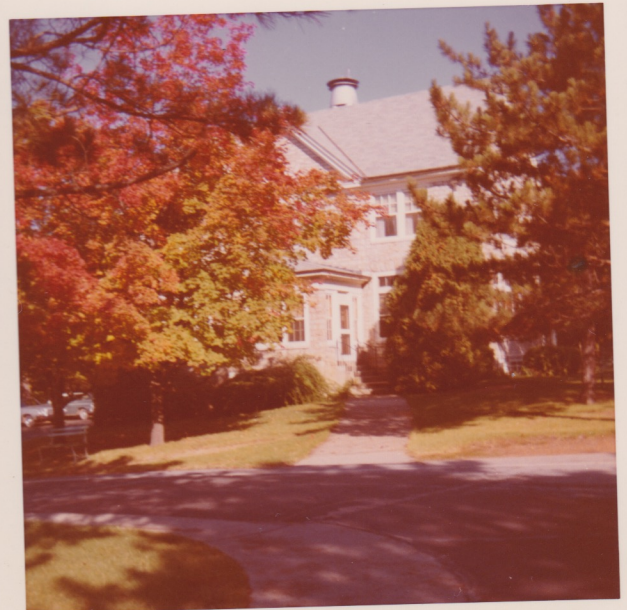
DESCRIPTION OF CONSTRUCTION Foundation-concrete; roof-asphalt shingles; walls-stone reinforce; floors (1st,2nd,3rd) wood over concrete; basement concrete; building eliminated from Life Safety Code Project

GENERAL CONDITION OF BUILDING EXCELLENT V. GOOD GOOD FAIR POOR V. POOR
X

1. Replace Cottage No. 1 with insulated windows - Energy Conservation item.
2. Replace asphalt shingle roof.
